WEAR AND EROSION CHARACTERISTICS OF A  
CAST COBALT BASE ALLOY

William T. Ebihara

Army Weapons Command  
Rock Island, Illinois

SWERR-TR-73-2

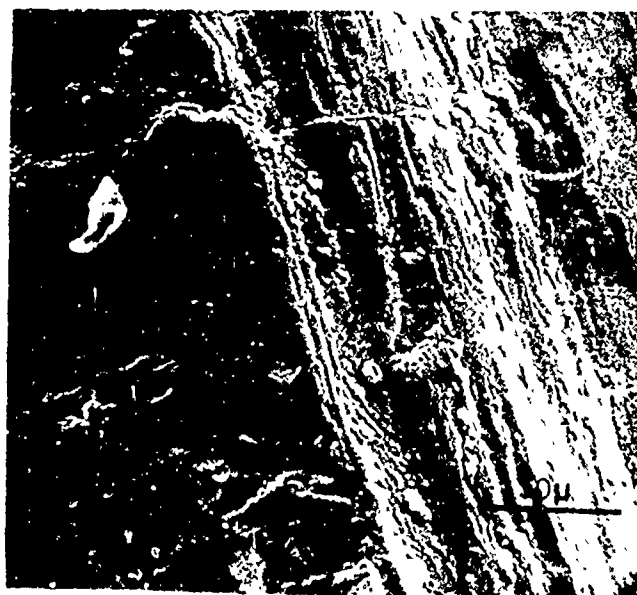
FIGURE 8 Bore Surface after 3000 Rounds (SEM)

After 100 rounds, the corners of the rifling became rounded and the transverse surface cracking was intensified. The land surface became much smoother and widespread layering of the propellant debris was noted (Figure 7). After 3000 rounds, the surface cracks appeared quite pronounced (Figure 8a) and debris was extruded into the crack openings (Figure 8b). No evidence of the original roughened surface or striations on the land was noted, and the density of cracks appeared much higher for the land surface compared with the groove region.
